HUGHES AIRCRAFT COMPANY

AN EVALUATION OF COMPOSITE TEFLON-ALUMINUM FOIL BLADDERS FOR THE SURVEYOR VERNIER PROPULSION SYSTEM

2 March 1967/SSD 78020

Performed in response to
JPL Change Order No. 119, dated 13 May 1966

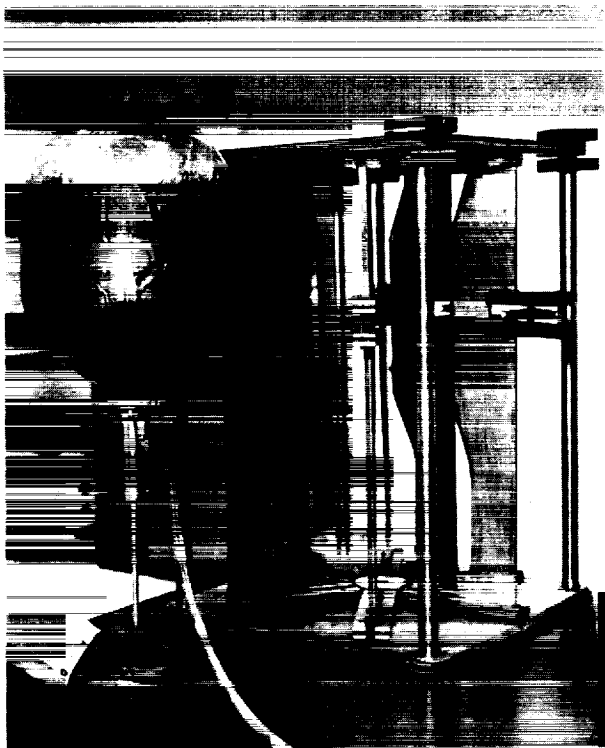
Figure 5-2. Insertion Tool and
Collapse Fixture
(Photo A16916)

- 1) The bladder is assembled in the insertion tool (Figure 5-2) and placed inside the blades which are fully open.
- 2) A plastic cover is thrown over the collapsing fixture, and a heat gun capable of 160° F exhaust temperature is inserted under the edge of the cover. The heat gun is allowed to run about 10 minutes before the collapse is started.
- 3) The collapse is begun by pulling both ends of the nylon cord which runs through the blade pulleys. During the collapse, a slight positive pressure (about 1 psig) is maintained in the bladder to assure a smooth collapse around each blade. Some hand tension on the plate is necessary to keep it moving as the bladder collapses and elongates.

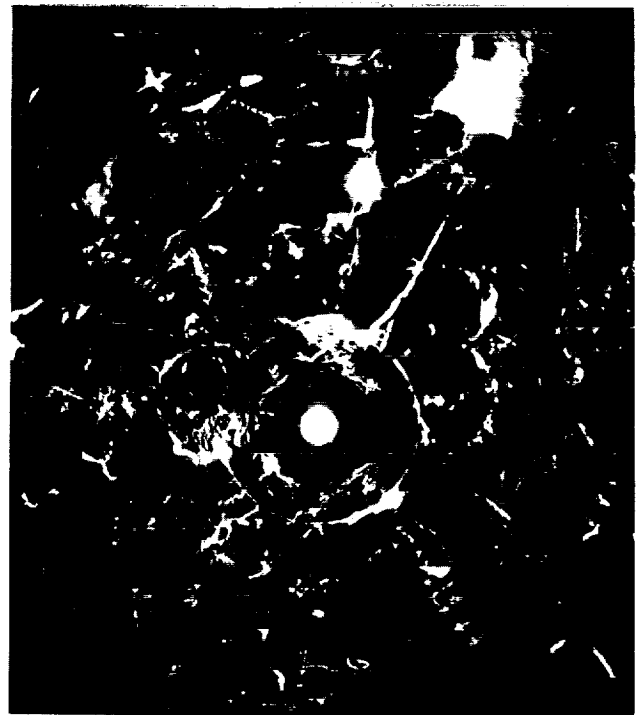
Figure 10-5. Bladder 3A Interior
(Photo A17216)
